PROJECT: Midnite Mine Remediation**REPORT NO:** 2021-02**OWNER:** Newmont/Dawn Mining**OPERATOR:** Newmont/Dawn Mining**SUMMARY OF WORK ACTIVITIES OR EVENTS FOR THIS REPORTING PERIOD:**

This weekly report provides a summary of Midnite Mine Site (Site) remediation action (RA) construction activities, quality assurance (CQA), quality control (CQC) and engineering activities for the period April 2 - 8, 2021. The Site activities discussed in this weekly report include, but are not limited to: Site Health, Safety, and Security; Community Liaison, Project Meetings, Regulatory Oversight, Site Visitors; Site Mobilization; RA Activities; Project Documentation; and Site Inspections.

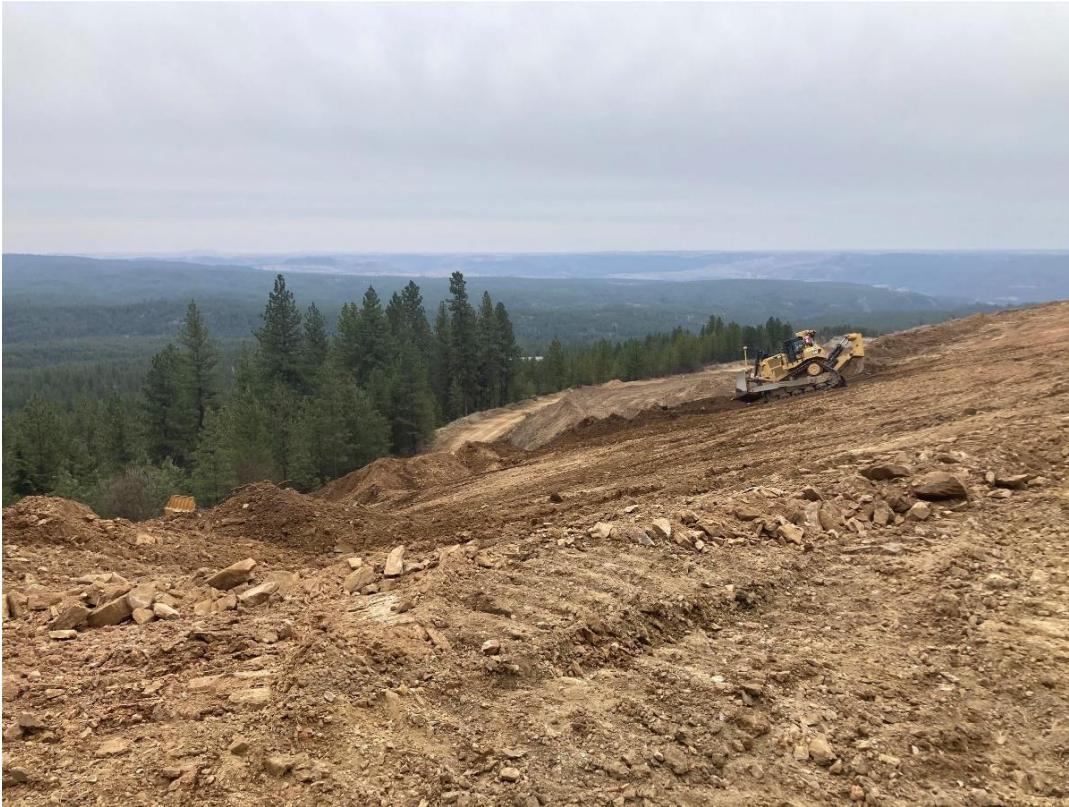
Photo 1 – Pit 4 Overburden material being dozed to the east for load out.

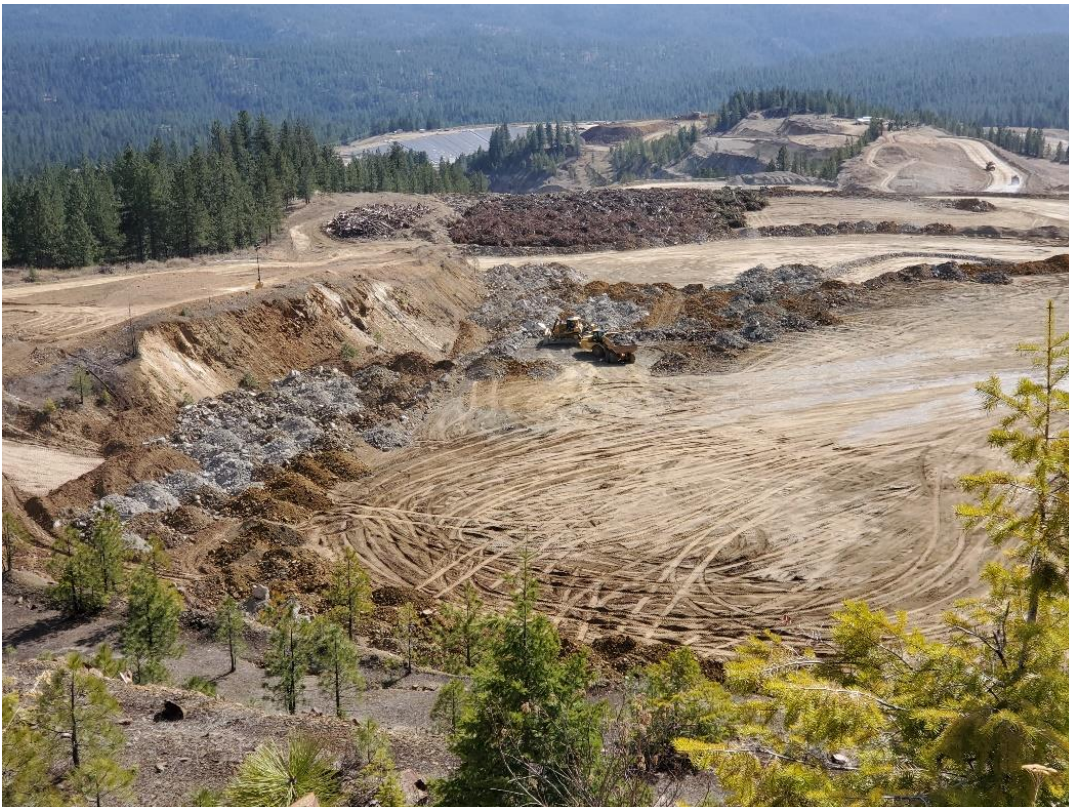
Photo 2 – Overview of Pit 4 - Looking to the South Placement of Low Activity/Low Reactivity Mid-SWRP Material

- Newmont continued excavating, hauling and placing low activity/low reactivity material from the west side of the South Waste Rock Pile (SWRP) and high activity/high reactivity material from Protore Stockpile 4 to Pit 4. A small amount of material was also excavated from the Pit 4 Overburden Pile. Material from the SWRP and Pit 4 Overburden Pile were placed along the outside perimeter of the Pit 4 Waste Containment Area (WCA) with Stockpile 4 material placed in the middle of the WCA in accordance with the design and specifications. Estimated quantities, based on load counts, are presented in Table 1.

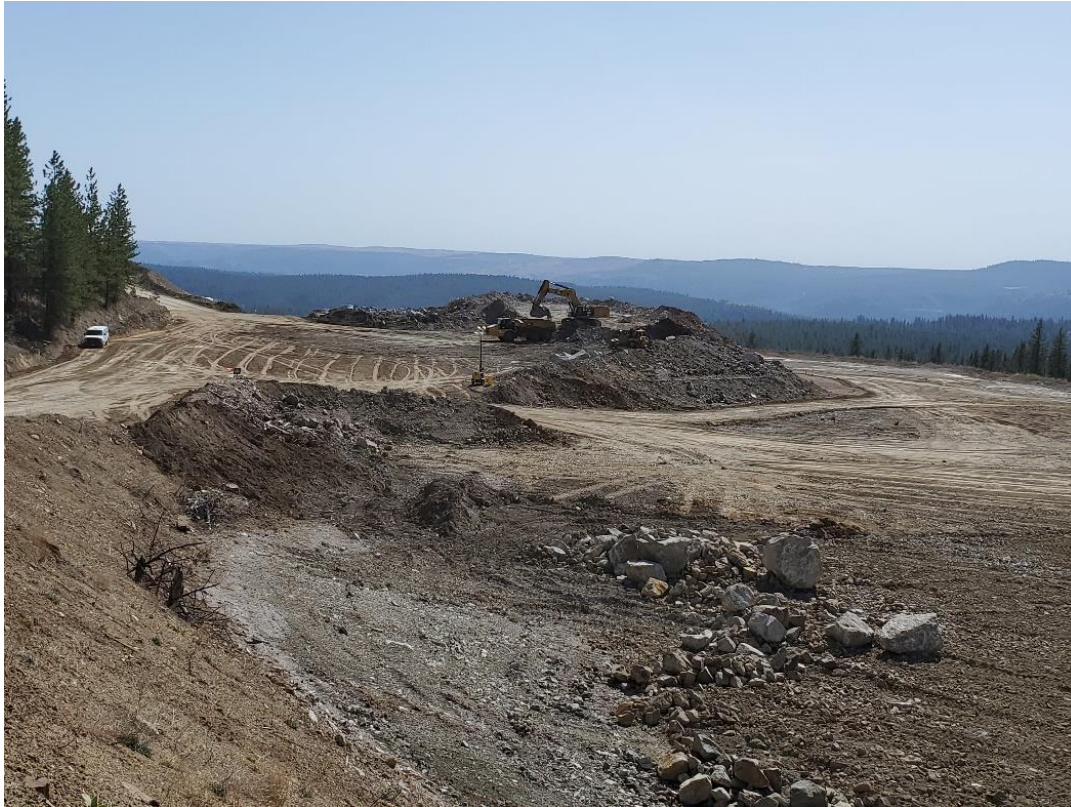
Photo 3 – Excavation of Mid-SWRP Material Looking to the South

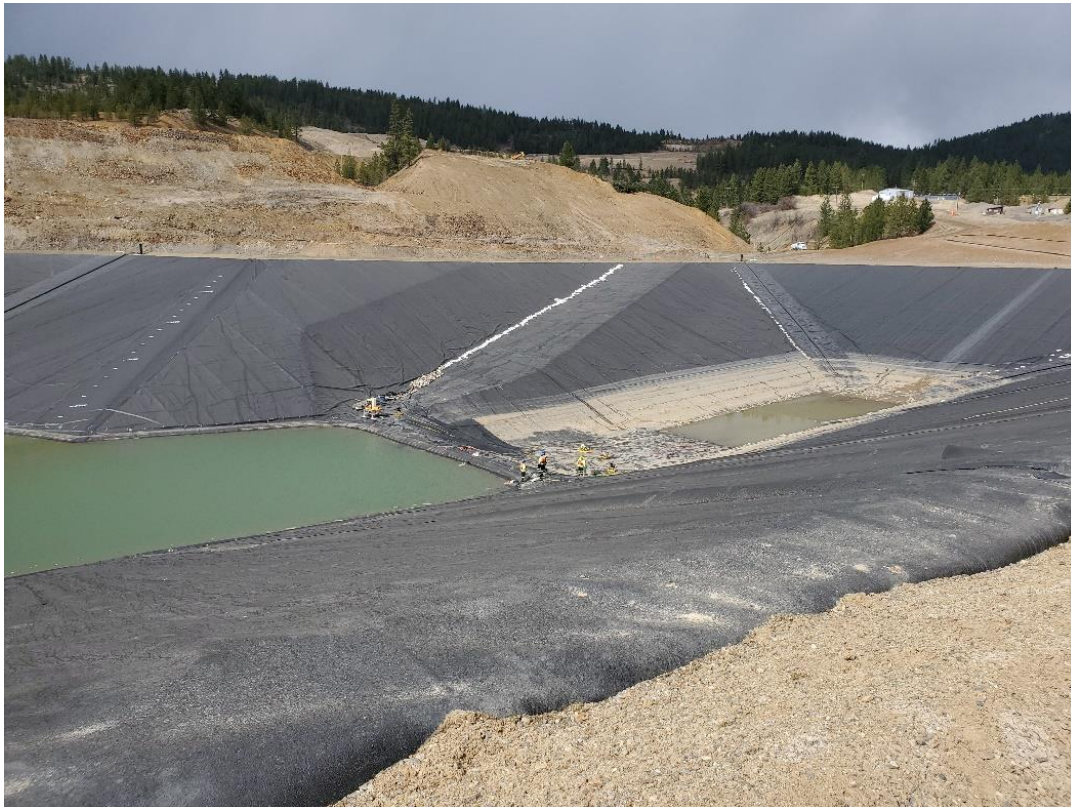
Photo 4 – Transferring Water from East Cell to the West Cell at the South Pond

- Newmont drained the South Pond East Cell and transferred water from the South Pond West Cell to Pit 3. Gary Arndt, Vikek Environmental Engineers, reviewed the pond liner installation on 7 APR and provided recommendations on addressing leakage through the primary liner.

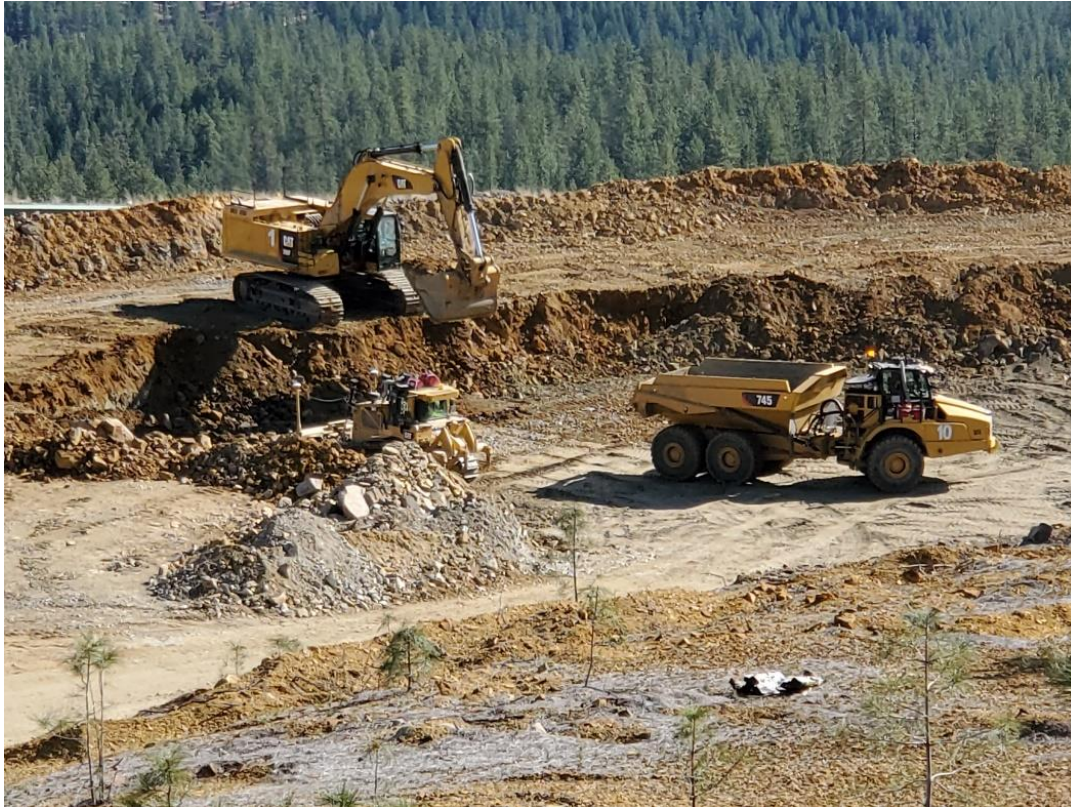
Photo 5 – Load-Out at Ore Stockpile SP-4 Looking South – 4-8-2021

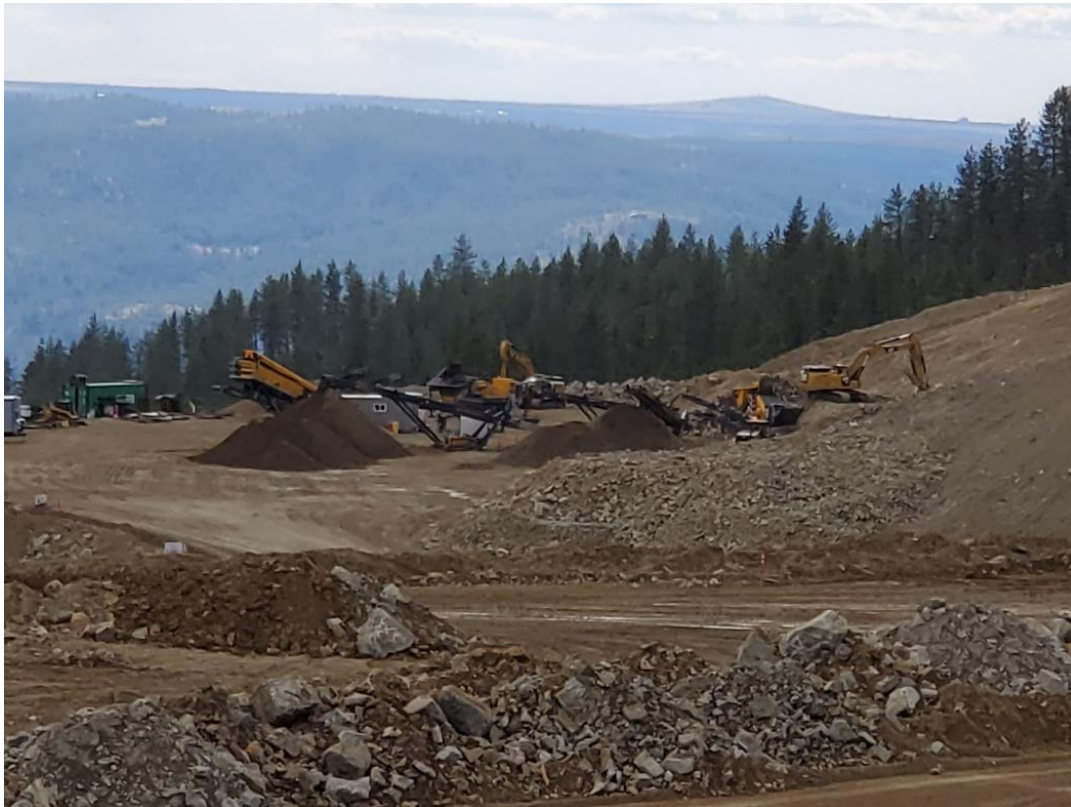
Photo 6 – Screening Activities at the HSWRP Looking Southwest – 4-8-2021

- SLV Earthmovers screened material from the Hillside Waste Rock Pile (HSWRP) to produce Drain Gravel and Geomembrane Bedding Material. Material was processed by screening only due to road restrictions delaying mobilizing the jaw crusher. Collection of Quality Control samples began. Produced materials were hauled to stockpile locations designated in the 2021 Crushing and Stockpiling Work Plan (Stantec, 2021). Estimated quantities of materials produced are presented in Table 1.

- Stantec performed Method 22 visual dust monitoring at the screening operation on the HSWRP on 5 APR. No dust was observed, so EPA Method 9 visible emissions observations were not performed.
